NIST NCSTAR 2: Vol. I

Report of the Technical Investigation of The Station Nightclub Fire

June 2005

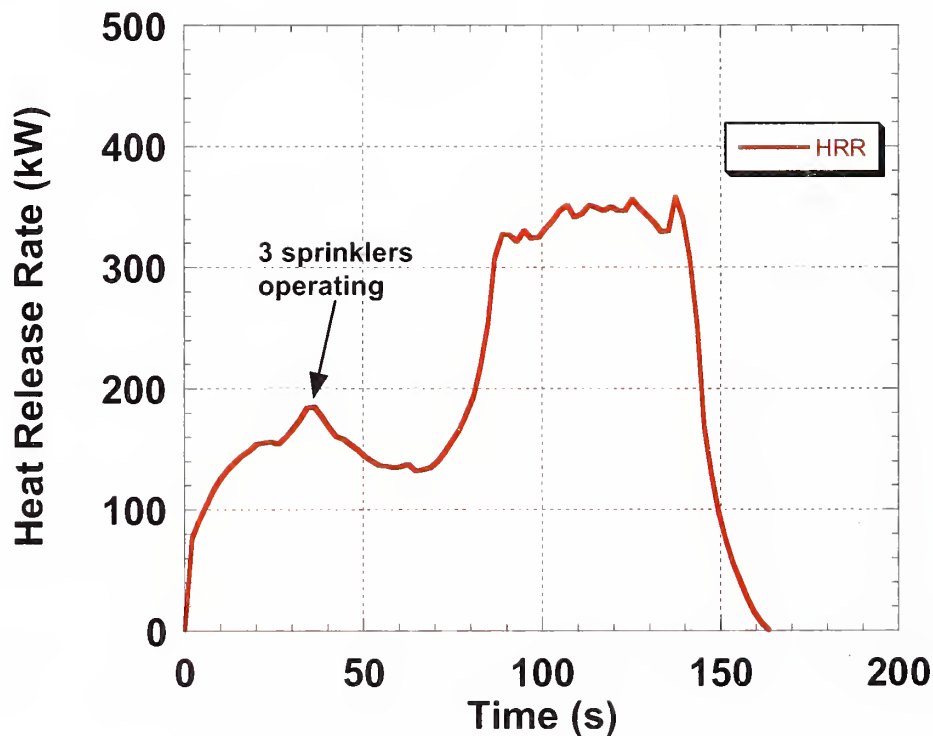
Figure 5-28 shows the FDS predicted heat release rate for the sprinklered enclosure. The experiment failed to produce enough combustion gases for the oxygen depletion calorimeter to measure a heat release rate. This was due to the rapid sprinkler activation, the effective fire suppression and the large volume of the enclosure. This graph demonstrates that in the simulation the fire grew after the activation of the third sprinkler (all were operating by 36 seconds). The decrease in HRR at approximately 140 seconds is when the shielded (dry) foam on the alcove ceiling burns itself out. In the experiment, foam above the line of water impact on the walls and the ceiling continued to burn after sprinkler activation as was shown in Figures 5-24 through 5-26.

Figure 5-28. FDS predicted heat release rate for the sprinklered case.

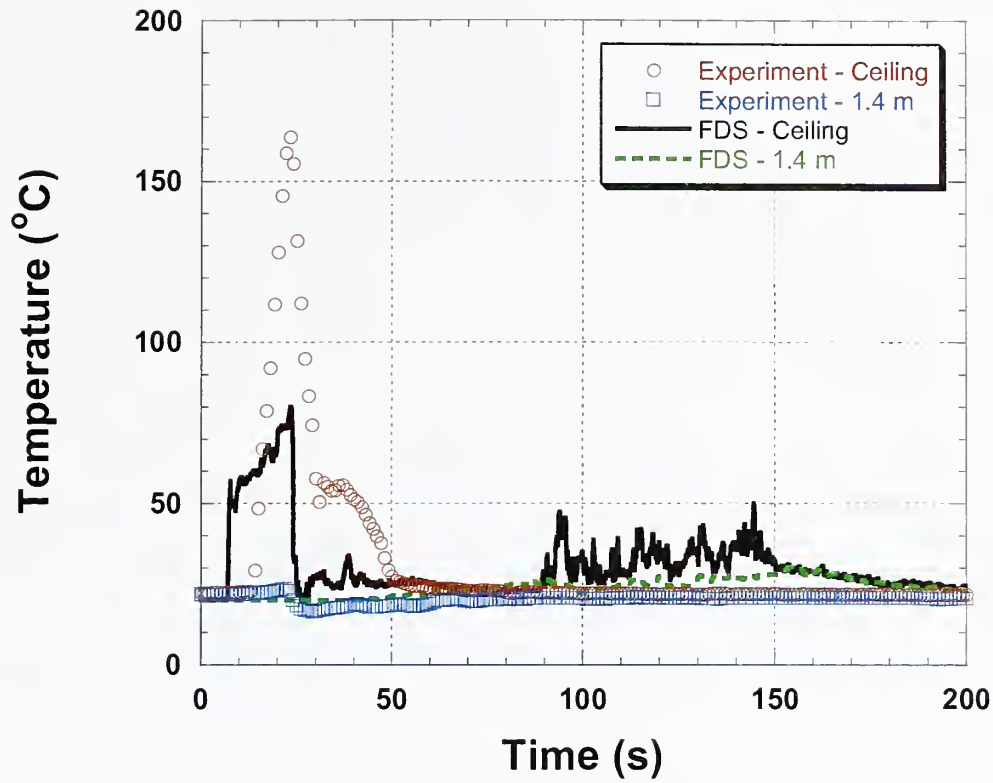
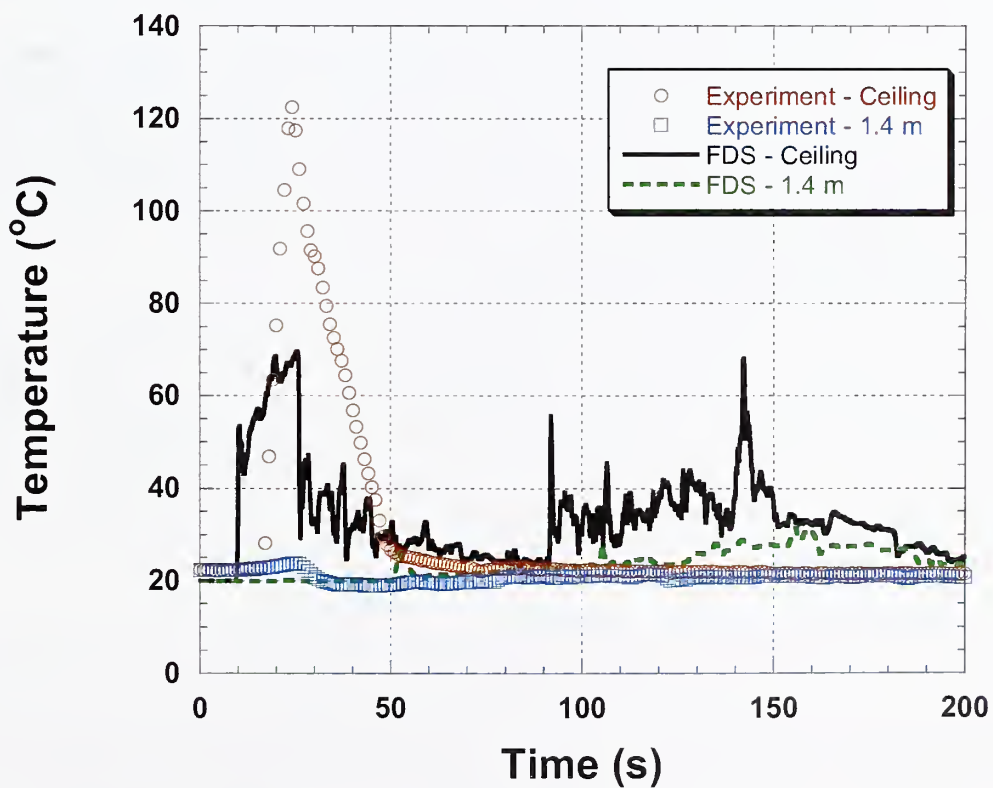
The comparison of the temperatures at Stations C and D are shown in Figures 5-29 and 5-30. In both cases FDS under predicts the temperatures near the ceiling. The FDS predictions in these two graphs have not been smoothed in order to show that the peak values near the ceiling are very close to the sprinkler activation temperature of 74 °C. Typically the temperature of the fire gases surrounding a sprinkler at the time of activation is approximately twice the listed temperature.

Due to the continued burning of foam on the ceiling of the alcove prior to complete extinguishment, the temperature in the simulated enclosure increases over the experimental temperatures. However, at the 1.4 m level above the floor the temperature never exceeds 35 °C (95 °F). This is well within the temperature tenability range.

Figure 5-29. Temperature comparison between the sprinklered fire experiment and the FDS simulation at Station C.

Figure 5-30. Temperature comparison between the sprinklered fire experiment and the FDS simulation at Station D.

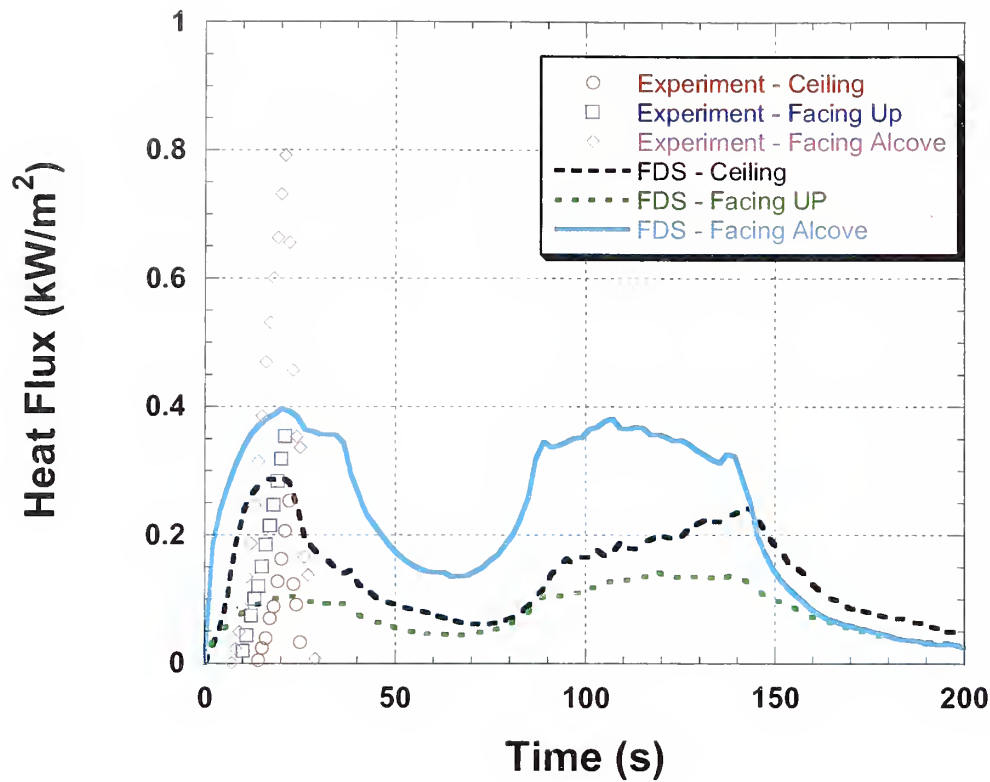
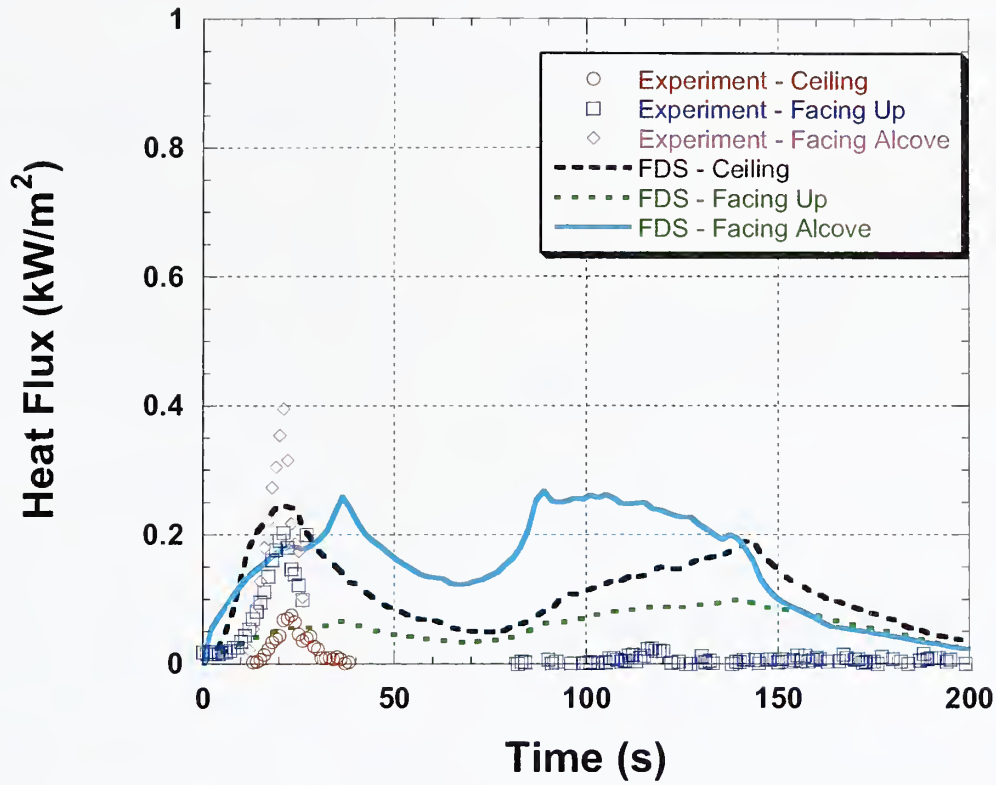
Figure 5-31. Heat flux comparison between the sprinklered fire experiment and the FDS simulation at Station C.

The comparison of the measured heat flux with the calculated heat flux is shown in Figures 5-31 and 5-32. Due to the limited fire growth and significant cooling by the water all of the heat flux values are less than 1 kW/m^2 . One notable difference between the experiment and the simulation is after the sprinklers activate in the experiment, the measured heat flux goes to zero, while in the simulation small values heat flux energy continue to be shown.

Figure 5-32. Heat flux comparison between the sprinklered fire experiment and the FDS simulation at Station D.

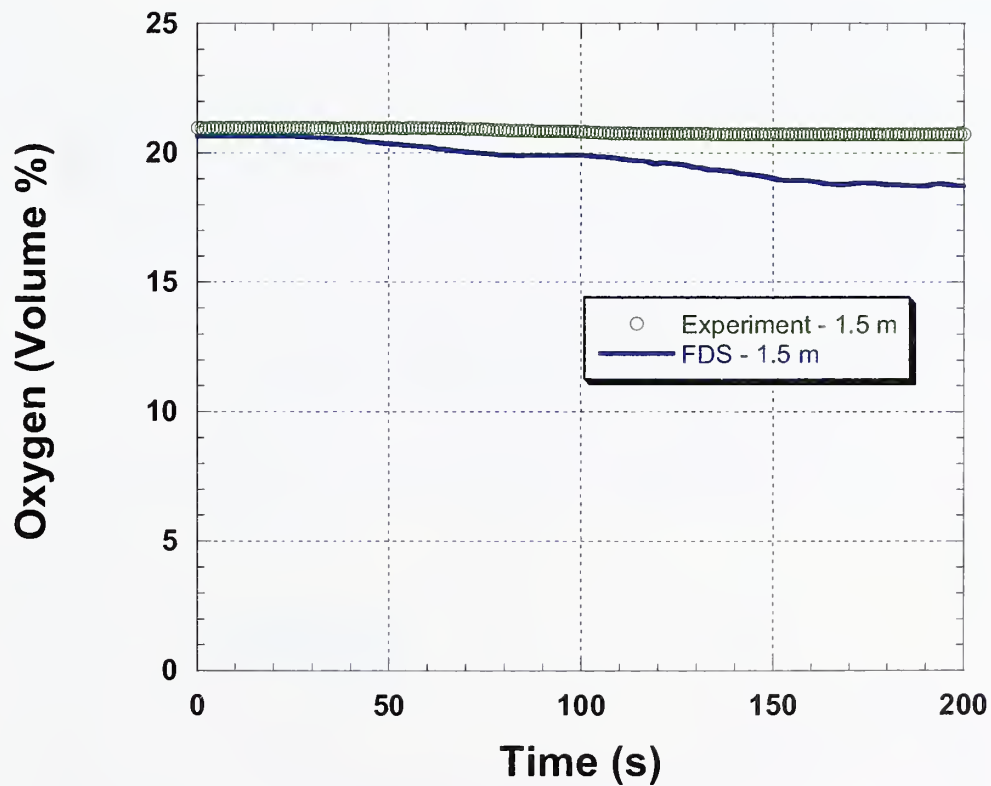
Figure 5-33 exhibits the comparison of the measured and predicted oxygen concentrations at Station C. The measured oxygen concentration shows only a slight decrease during the 200 seconds, while the simulation shows a decrease of approximately 2 percent. This may be due to the continued burning of the foam along the ceiling of the alcove that is taking place in the simulation of the experiment.

Figure 33. Oxygen volume fraction comparison between the sprinklered fire experiment and the FDS simulation at approximately 1.5 m above the floor at Station C.

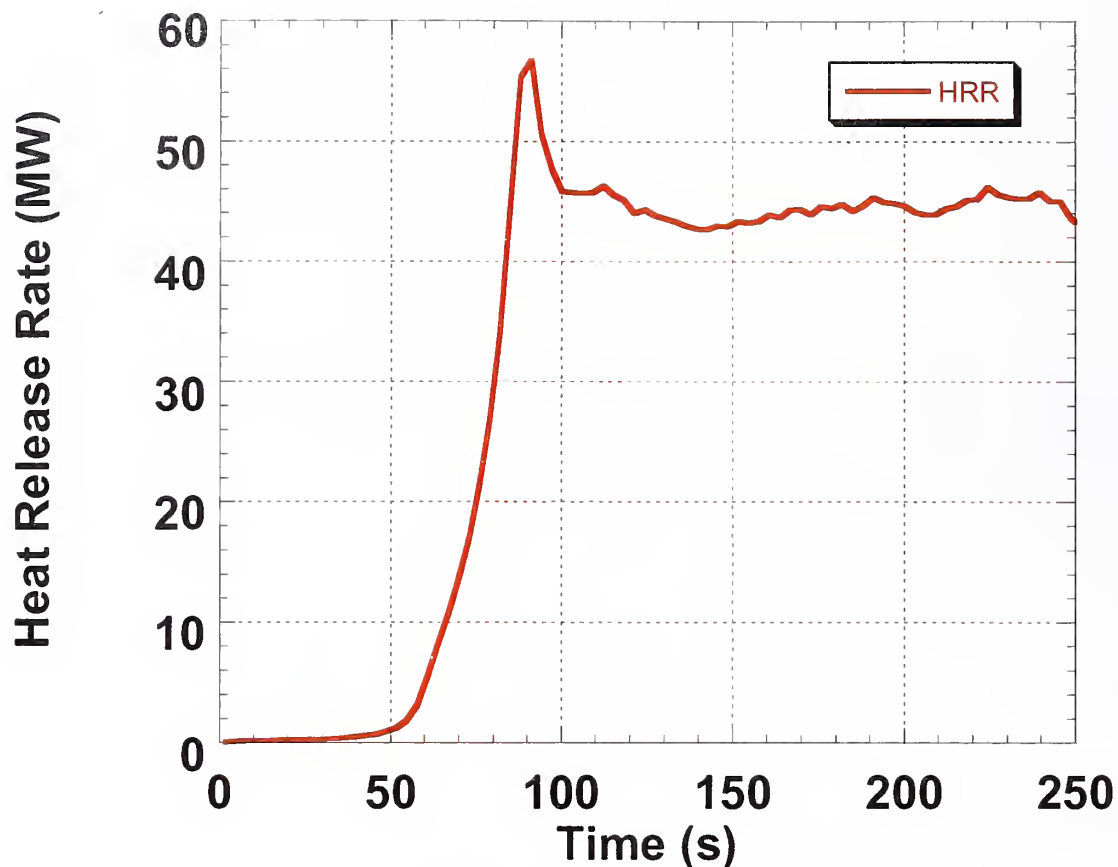
The total heat released in the fire is plotted in Figure 5-42. The graph shows that after the alcove became fully involved with fire, at approximately 50 to 60 seconds, the heat release rate increased from approximately 2 MW to 54 MW in less than 50 seconds. Hence the rate of increase was more than 1 MW per second. As the fire spread throughout the structure and the fire became oxygen limited the heat release rate became steady at approximately 45 MW for approximately 150 seconds. After that time, the simulation began to deplete the fuel contained in the interior finish materials. The fire in the actual nightclub had spread into the structure and burned in and through areas of the roof and walls by this time. The simulation only provided fuel based on the interior finish and did not account for fuel being provided by structural elements and materials in building outer envelope.

Figure 5-42. Total Heat Released in Building Fire Simulation as a Function of Time

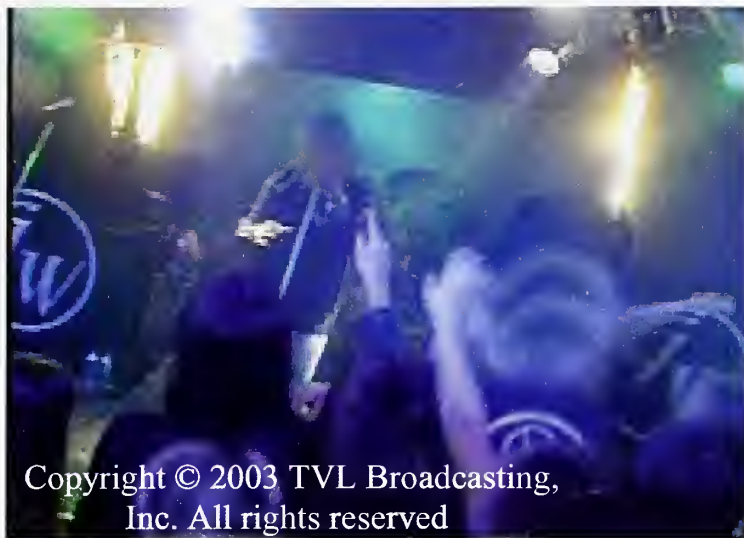
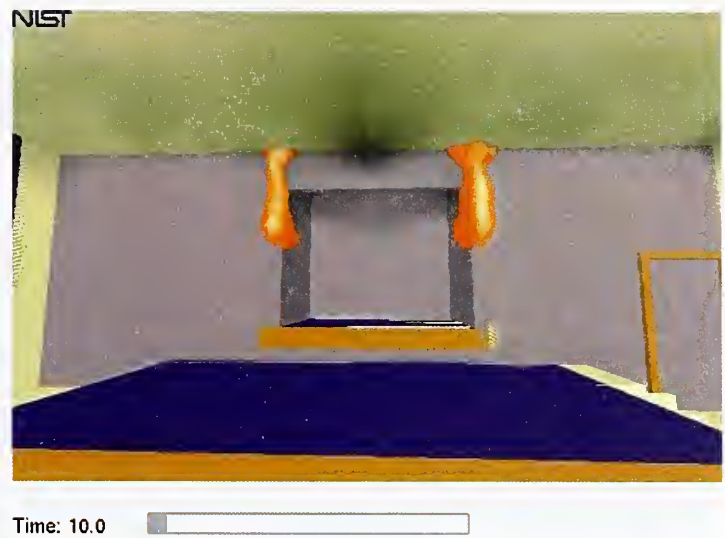
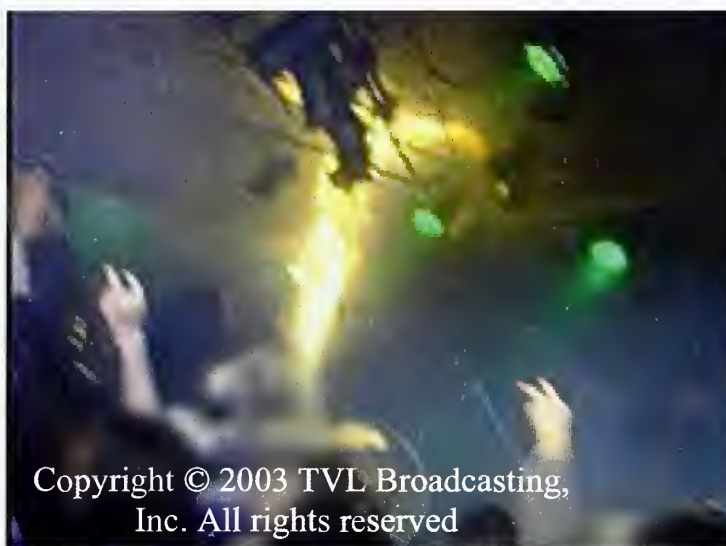
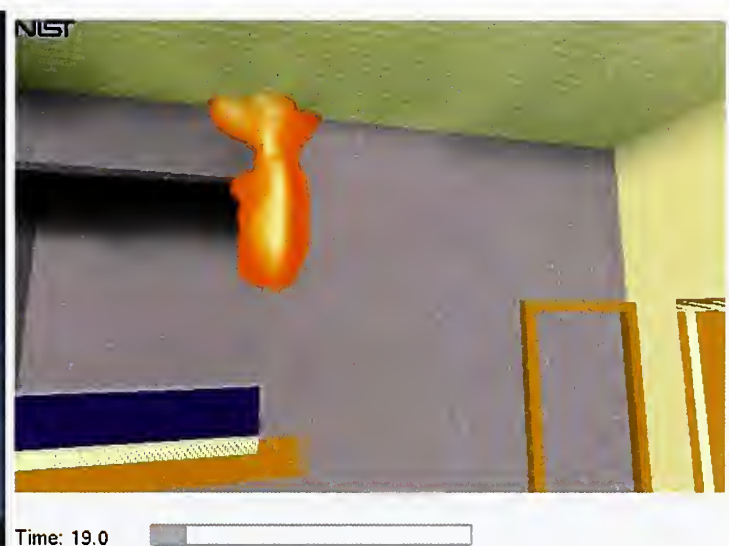
The images from the video in Figures 5-43 and 5-44 capture the initial state of the fires on each side of the platform shortly after the gerb discharge had stopped. At 10 seconds after ignition, the fire can be seen burning on two surfaces at each of the corners; this is also considered in the simulation with the placement of the ignition vents on both sides of the corner. In both the simulation and the actual incident the flames impinge on the ceiling within 20 seconds after ignition.

Figure 5-43. Initial growth of fire on foam at corner of the alcove (10 seconds)

Figure 5-44. Flames impinging on ceiling (19 seconds)

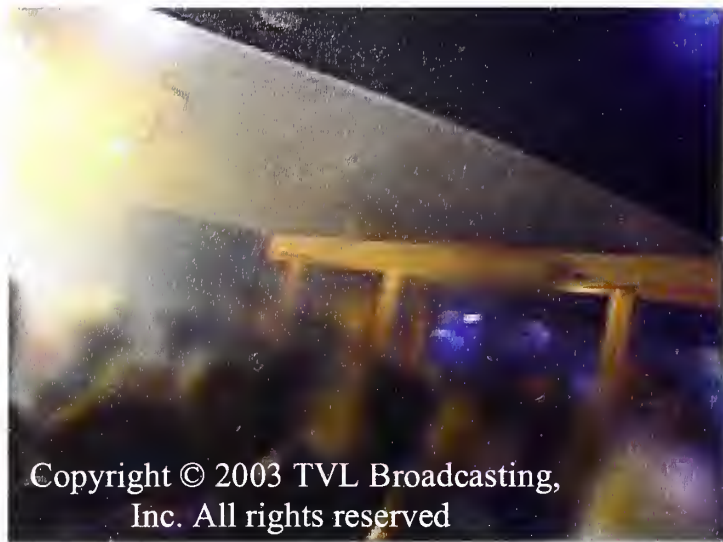
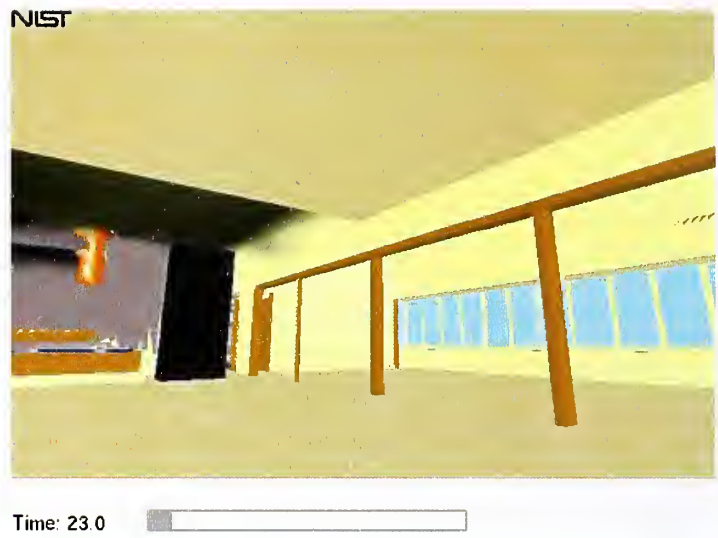
At 23 seconds after ignition, Figure 5-45, the videographer has begun to move toward the exit as have many in the crowd. Notice that many people are still facing the platform. The fire continued to grow and smoke has collected in the raised ceiling area over the dance floor. The smoke filling can be seen in the image from the simulation. (Note the black rectangular image on the floor is representative of the speaker cabinet, whereas the boundaries of the smoke layer are irregular.) At 53 seconds after ignition, the flames have grown and spread along the platform wall and into the alcove as shown in video image in Figure 5-46. In addition, the smoke is spreading across the lower level ceiling area toward the main exit. The flames have spread in the simulation as well and smoke is beginning to spill over from the dance floor area towards the exits and the main bar room, although it takes a few more seconds into the simulation for this to occur. Again the black rectangular objects on the floor are representative of speaker cabinets (near the platform) and the sound and lighting board (left side).

Figure 5-45. Videographer backing away from platform (23 seconds)

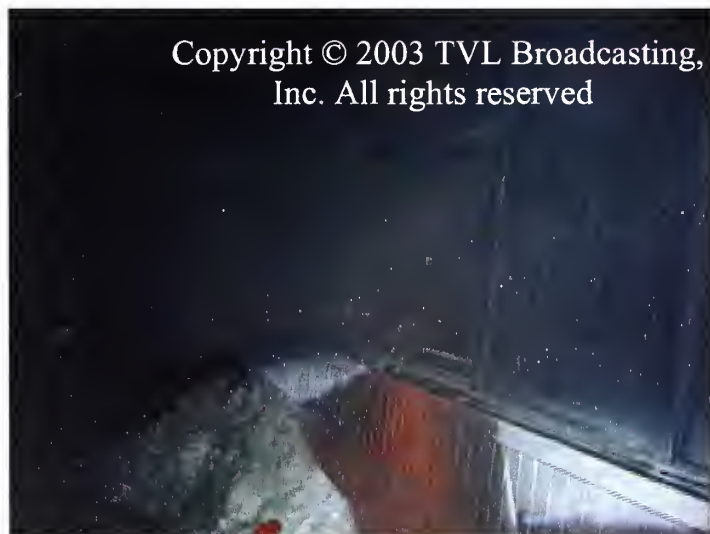
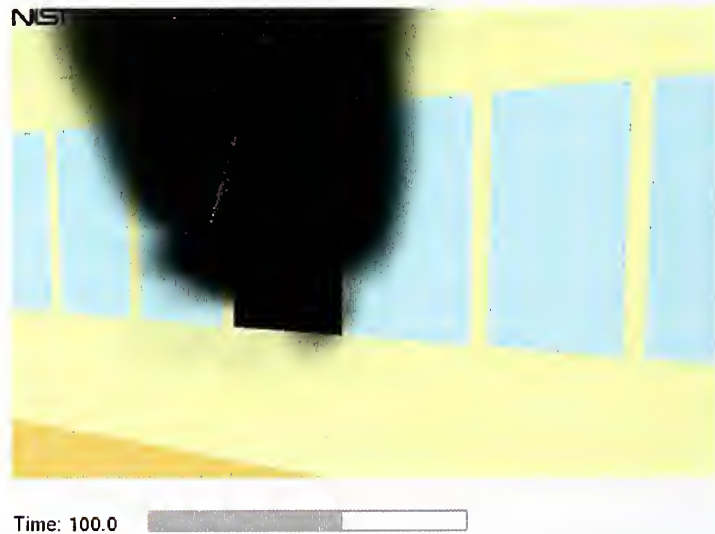
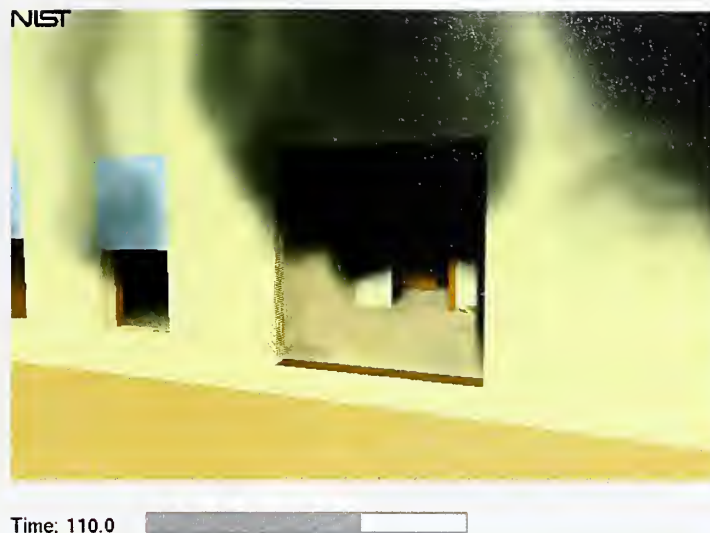
The videographer had exited the nightclub at approximately 70 seconds and headed toward the stage door. He then returns toward the main entrance and attempts to pass between the nightclub and the bus when he encounters a plume of black smoke pushing out of one of the window vents in the sunroom. The image from the simulation also shows a similar view. At approximately 110 seconds after ignition, smoke is flowing from the main entrance; the image from the simulation is given in Figure 5-48. The model did not account for people blocking the air flow into the doorway.

Figure 5-47. Smoke billowing outside from broken sunroom window (100 seconds)

Figure 5-48. Light smoke emanating from front door of nightclub (110 seconds)

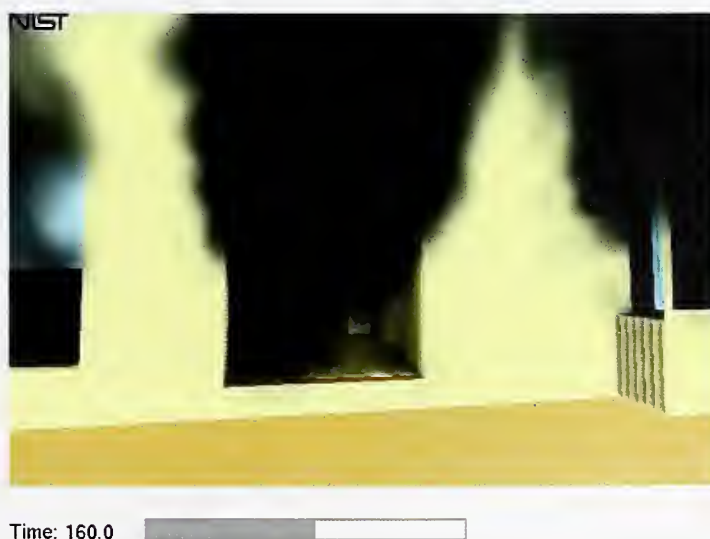
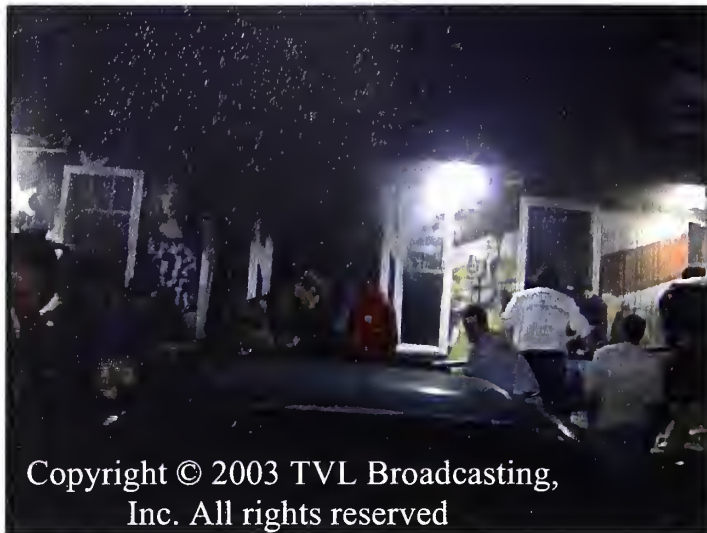
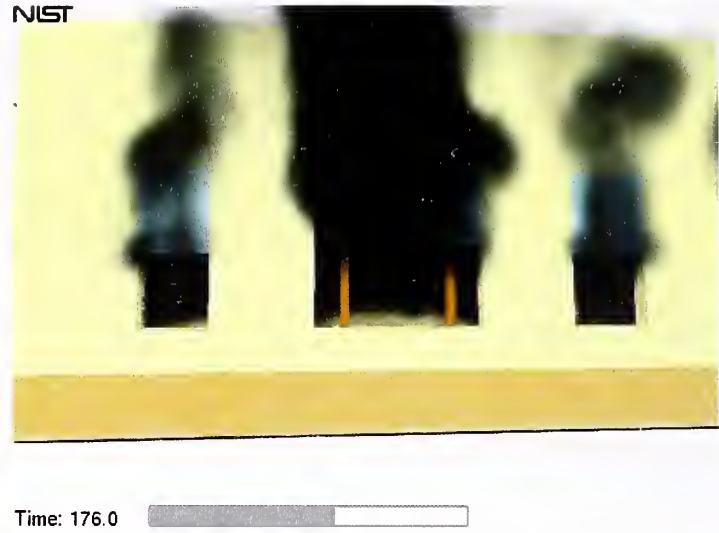
The Smokeview image in Figure 5-49 shows the smoke flow from the front door at 160 seconds after ignition in the simulation. In Figure 5-50, the simulated smoke flow from the main bar room windows is shown. More smoke is coming from the center window than the two side windows because the upper and lower portions of the center window have been removed while only the lower portion of the side windows are open in the simulation.

Figure 5-49. Heavy smoke leaving front door and open main bar window (160 seconds)

Figure 5-50. View of smoke plumes from front windows of horseshoe bar area (176 seconds)

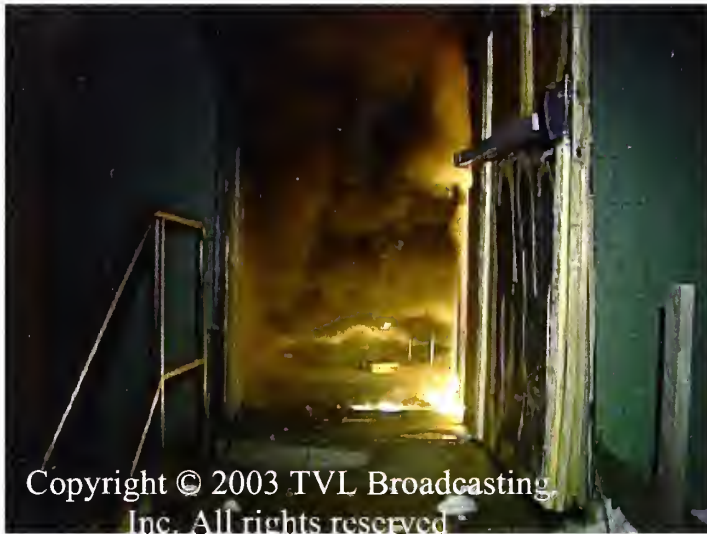
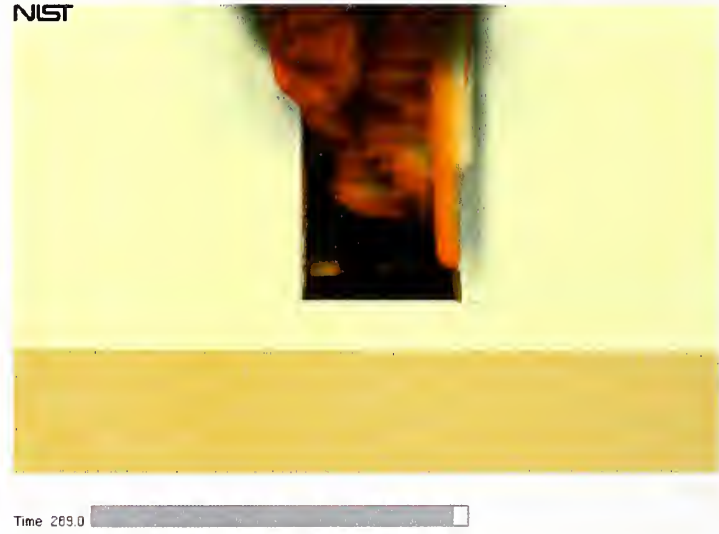
Figure 5-51. Looking into stage door exit (289 seconds)

The videographer moves around to the stage door again. The view inside the open door at approximately 289 seconds after ignition is shown in Figure 5-51. The image from the simulation agrees with the video image on the level of combustion products in the doorway. However without a comparison to the temperature in the doorway, the mixture fraction alone would indicate that more flames are in the area of the stage doorway than can be seen in the video image. The videographer continues around to the backside of the nightclub, at 300 seconds after ignition flames are coming through a small portion of the back wall (south wall) of the dance floor area and smoke is leaking from the bathroom hallway wall. The videographer moved toward the front of the nightclub again, at 309 seconds flames can be seen in the area of the front door. It takes another 25 seconds before he is in a position to record the images of the flames coming from the sunroom windows and the main door. The simulation stops at 300 seconds after ignition, short of the time that the entire nightclub reaches flashover conditions.

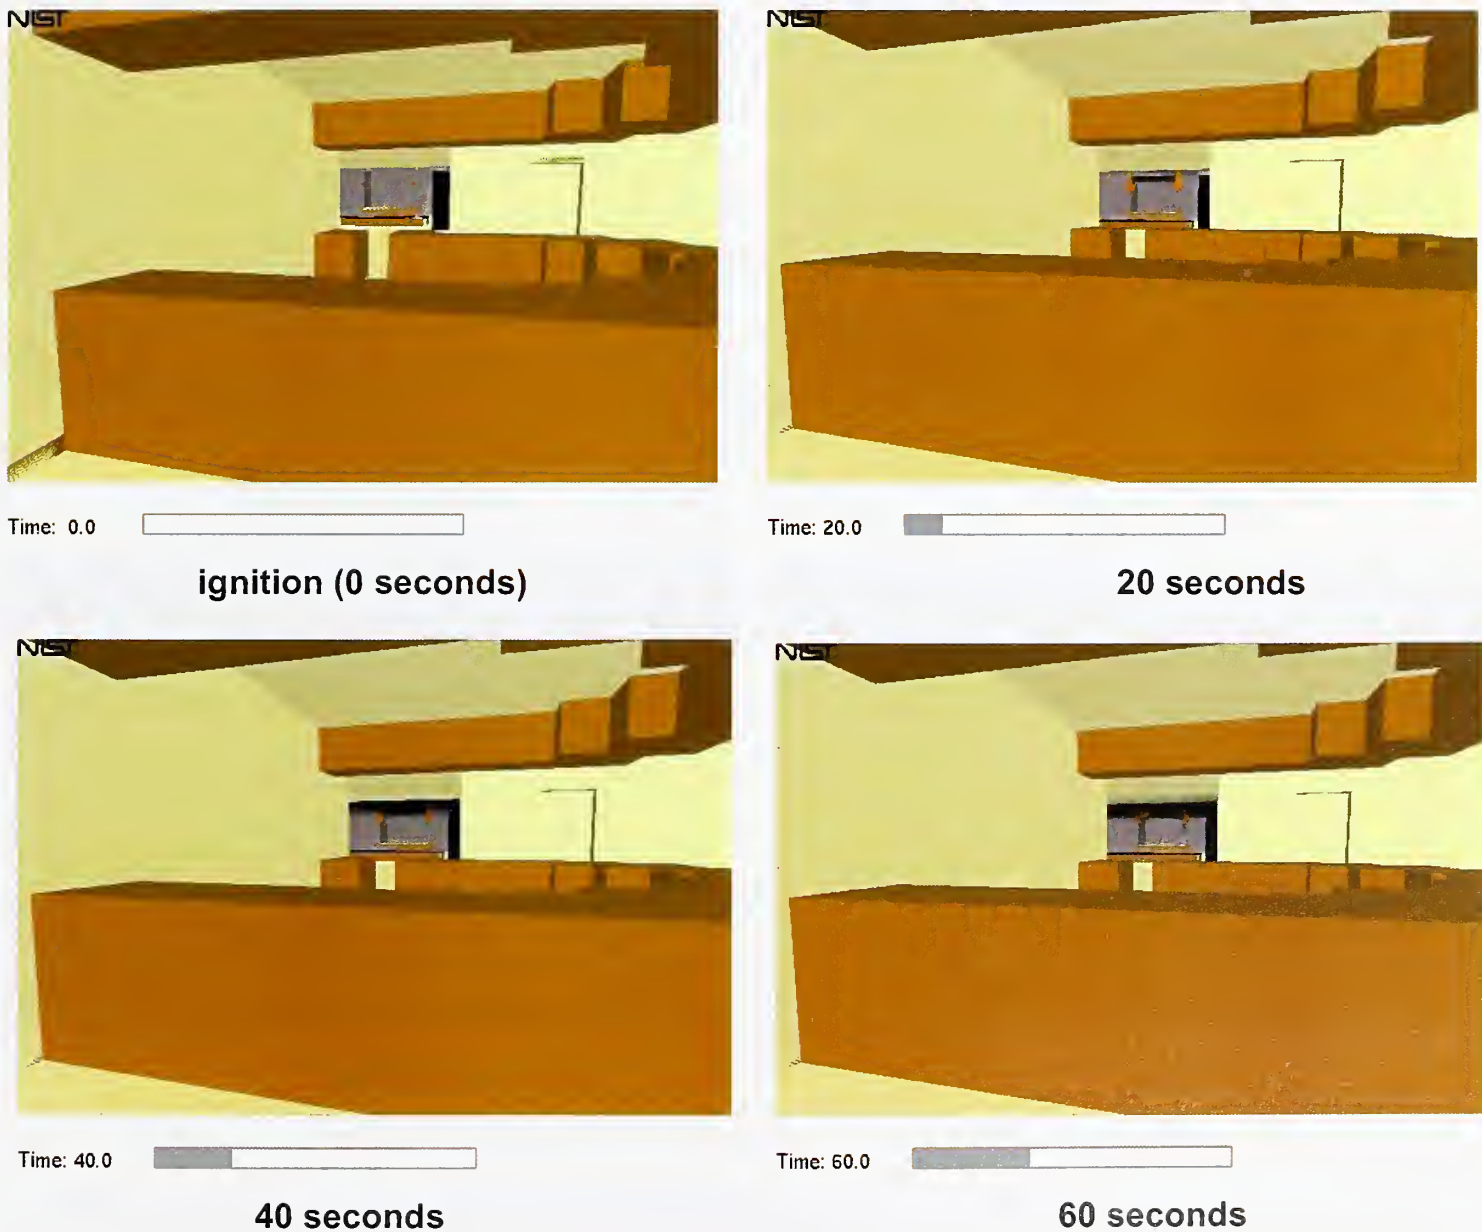
Figure 5-53a. View of fire from beyond horseshoe bar, looking at platform (0 - 60 seconds)

Smokeview images were rendered at certain time intervals from the view looking through the far side of the main bar to the platform area. (See Figures 5-53a,b.) This allowed for the conditions to be observed at several key locations: the platform area, the entrance to the main exit way and the main bar area. Many of the occupants traveled this path as either they were able to exit or were overcome by the conditions prior to being able to do so. The fire developed quickly in the platform area as the foam burned and resulted in the alcove becoming fully developed with fire. Once that occurred the flames involved the entire rear wall and spread toward the main entrance, generating large amounts of smoke. At 70 seconds after ignition, the smoke can be seen in the area of the main entrance to the nightclub. This is consistent with the WPRI video. As the videographer leaves the nightclub, at approximately 70 seconds after ignition, smoke is flowing over the heads of people in the main entry foyer. However, even 80 seconds after ignition visibility remained high in the main bar room. This changed suddenly as the smoke and hot gases that were spilling out of the now-filled raised ceiling above the dance floor quickly spread to the main bar room. Based on the FDS simulation, within another 20 seconds, 100 seconds after ignition visibility was impaired, and remained so throughout the rest of the 300 seconds simulation. Flames can be seen in the last three images of Figure 5-53b as the surfaces in the main bar area began to burn.

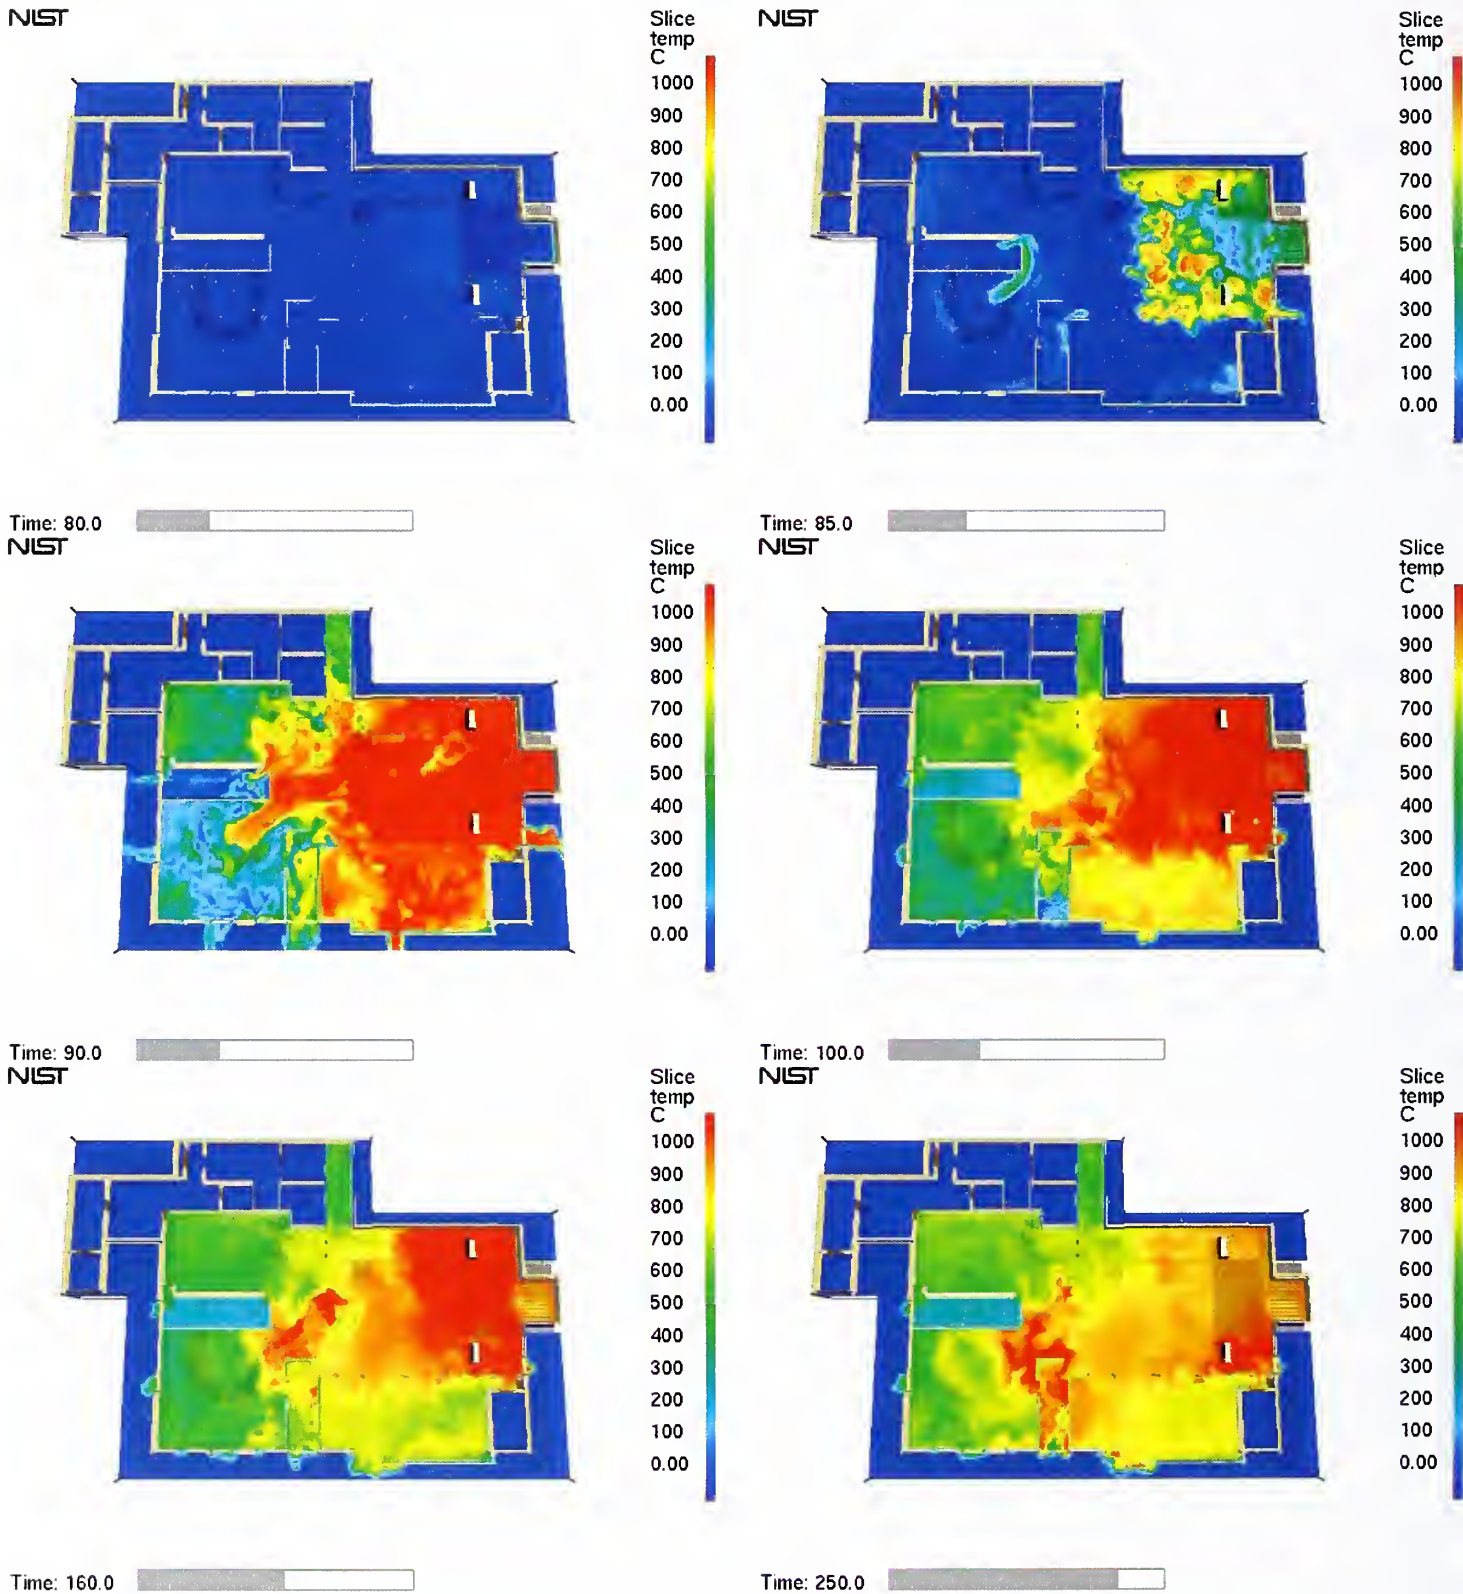
Figure 5-55. Temperatures at 1.5 m (5 ft) above the floor, 80 seconds to 250 seconds

Temperatures increase dramatically shortly after the alcove area reaches flashover conditions at approximately 65 seconds and then the platform area becomes fully involved in flames. The first two images in Figure 5-55 show the temperatures at 1.5 m (5 ft) above the floor at 80 and 85 seconds. Within that 5 second time interval the simulation predicts that dance floor area of the nightclub would have become untenable due to temperature. By 100 seconds after ignition, the simulation shows a large portion of the structure had become untenable due to temperature at the 1.5 m (5 ft) level. Figure 5-55 continues with the presentation of simulation temperature results from 160 seconds to 250 seconds after ignition. During this time interval temperatures continue to remain in the untenable range throughout the simulated nightclub, with the exception of areas that are considered closed off from the hot gas flow such as the

bathrooms, office and storage areas. These areas were assumed to be separated from the rest of the nightclub by closed doors, so they were modeled without a path for the gases to enter the spaces, hence they appear to remain in the tenable range. The kitchen area has an open door from the dart room and an open door that exits to the outside. The hot gas flow goes directly from the dart room to the exit doorway. This leaves the kitchen at a cooler temperature than the surrounding rooms.

The comparison between the temperatures 1.5 m (5 ft) above the floor in the non-sprinklered simulation (Figure 5-55) and in the sprinklered configuration (Figs. 5-66a and 5-66b) show dramatically different thermal conditions. (Note the large difference in color scales.) During the non-sprinklered simulation temperatures exceeded 1000 °C (1830 °F) in the platform and dance floor areas, and in the main bar room they exceeded 500 °C (930 °F) within 100 seconds. In the sprinklered simulation, the temperature exceeds 25 °C at head height only near the platform; following sprinkler activation around 20 seconds, the thermal environment remains close to ambient up until the time the fire is fully extinguished at 120 seconds.

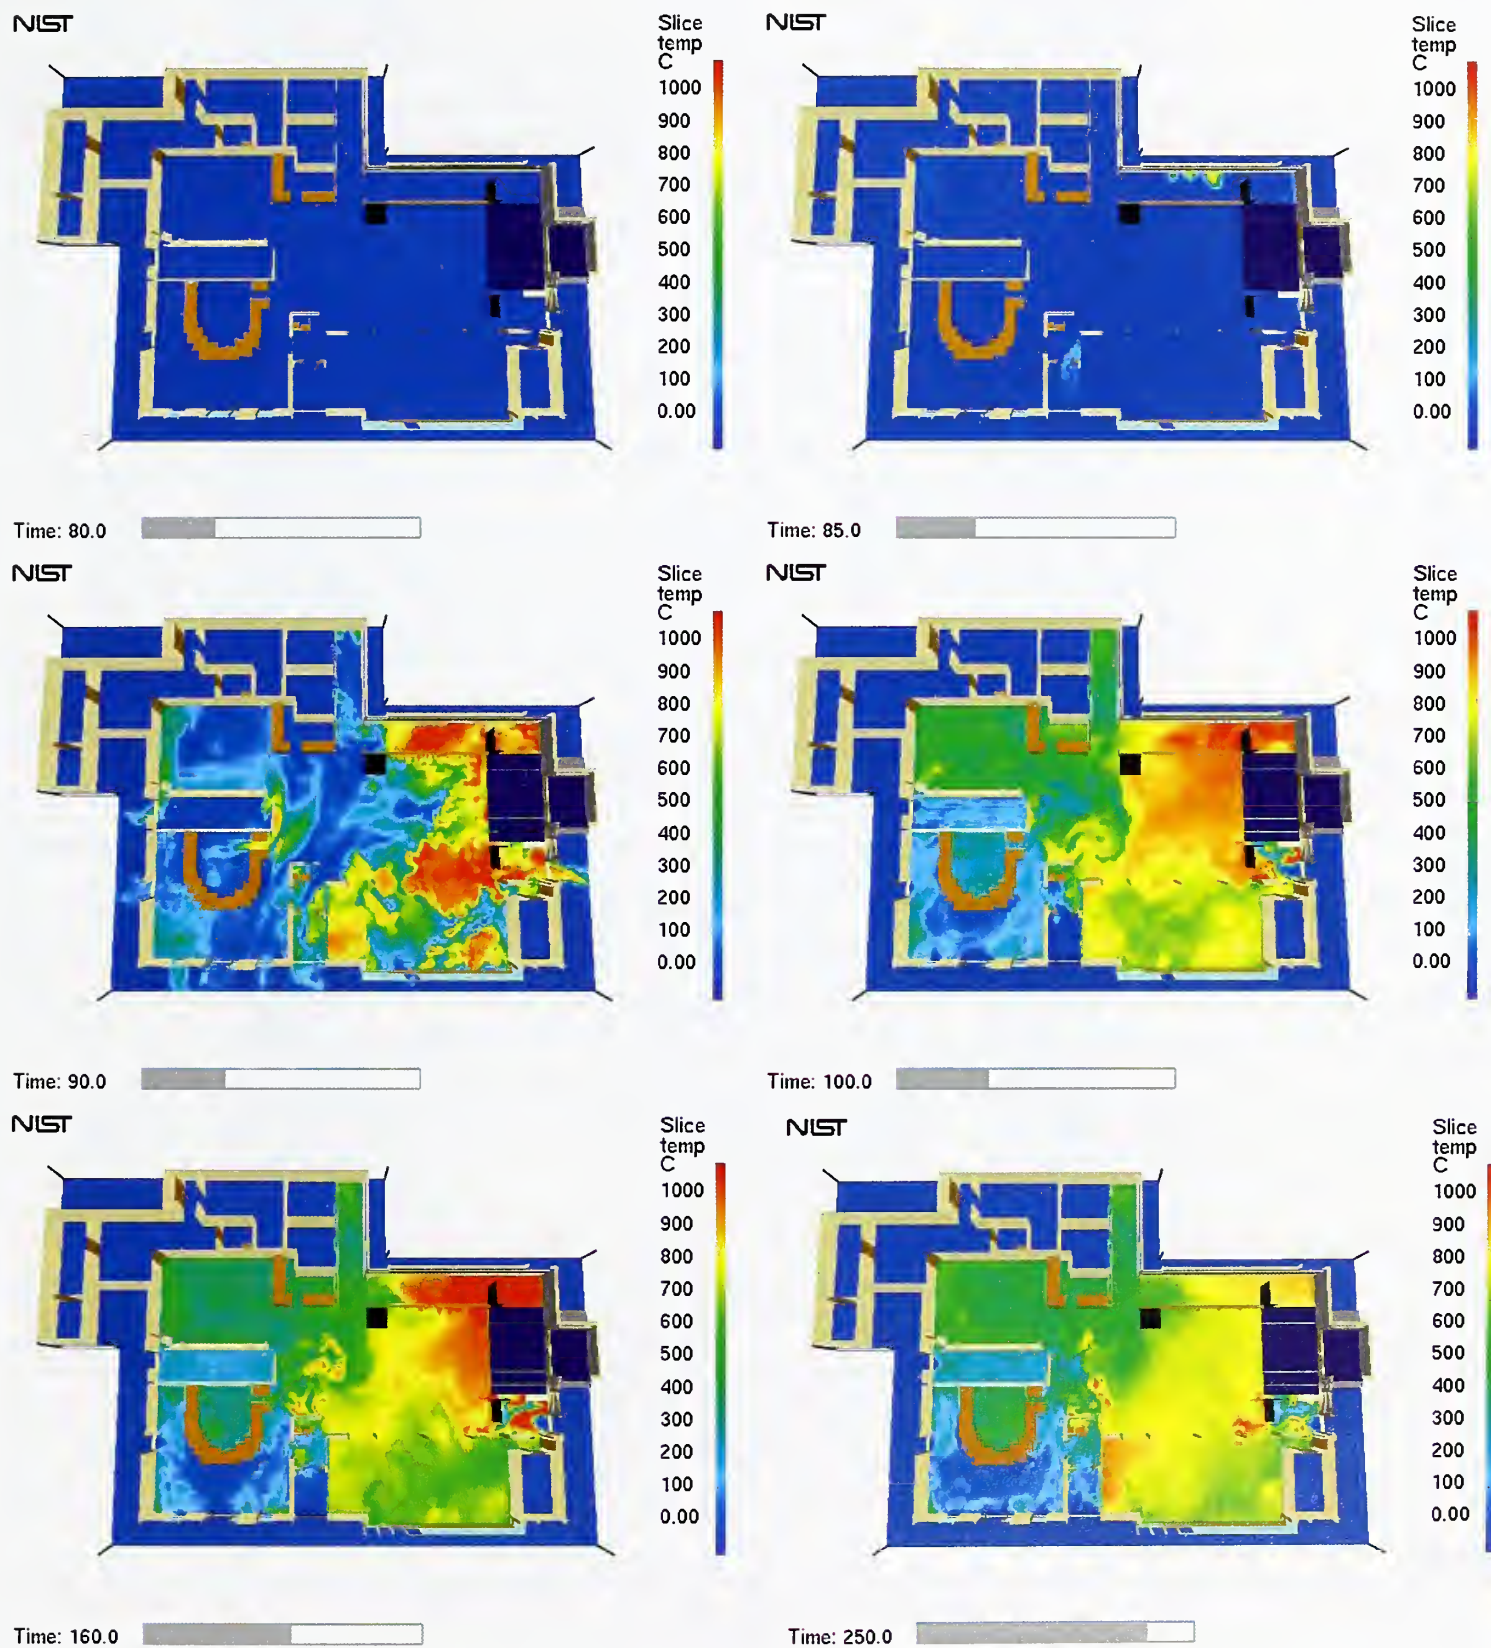
Figure 5-56. Temperatures at 0.6 m (2 ft) above the floor, 80 seconds to 250 seconds

At the 0.6 m (2 ft) height above the floor conditions remain tenable for a longer period of time than at the higher elevation. Figure 5-56 contains images captured at the same time intervals as in the previous figure. One can see that the dance floor and adjacent areas reach untenable temperatures in the simulation within 90 seconds after ignition. The sunroom and dart room areas are predicted to reach untenable temperatures within another 10 seconds.

The significant differences in temperature between the 1.5 m (5 ft) elevation and 0.6 m (2 ft) occur in the main bar room and the main entrance. This area remains tenable at the lower level due to the inflow of fresh air through the open windows and open doorways. The cooler temperatures toward the floor at both the front door and main bar area explain why occupants were seen in the WPRI video escaping from the windows and doorway later into incident. The temperatures in later images do not change significantly regarding areas that have untenable conditions versus areas that remain tenable based on temperature only.
